Thoughts about a 500-year plan (give or take 499 years)

Harrison West Condominium

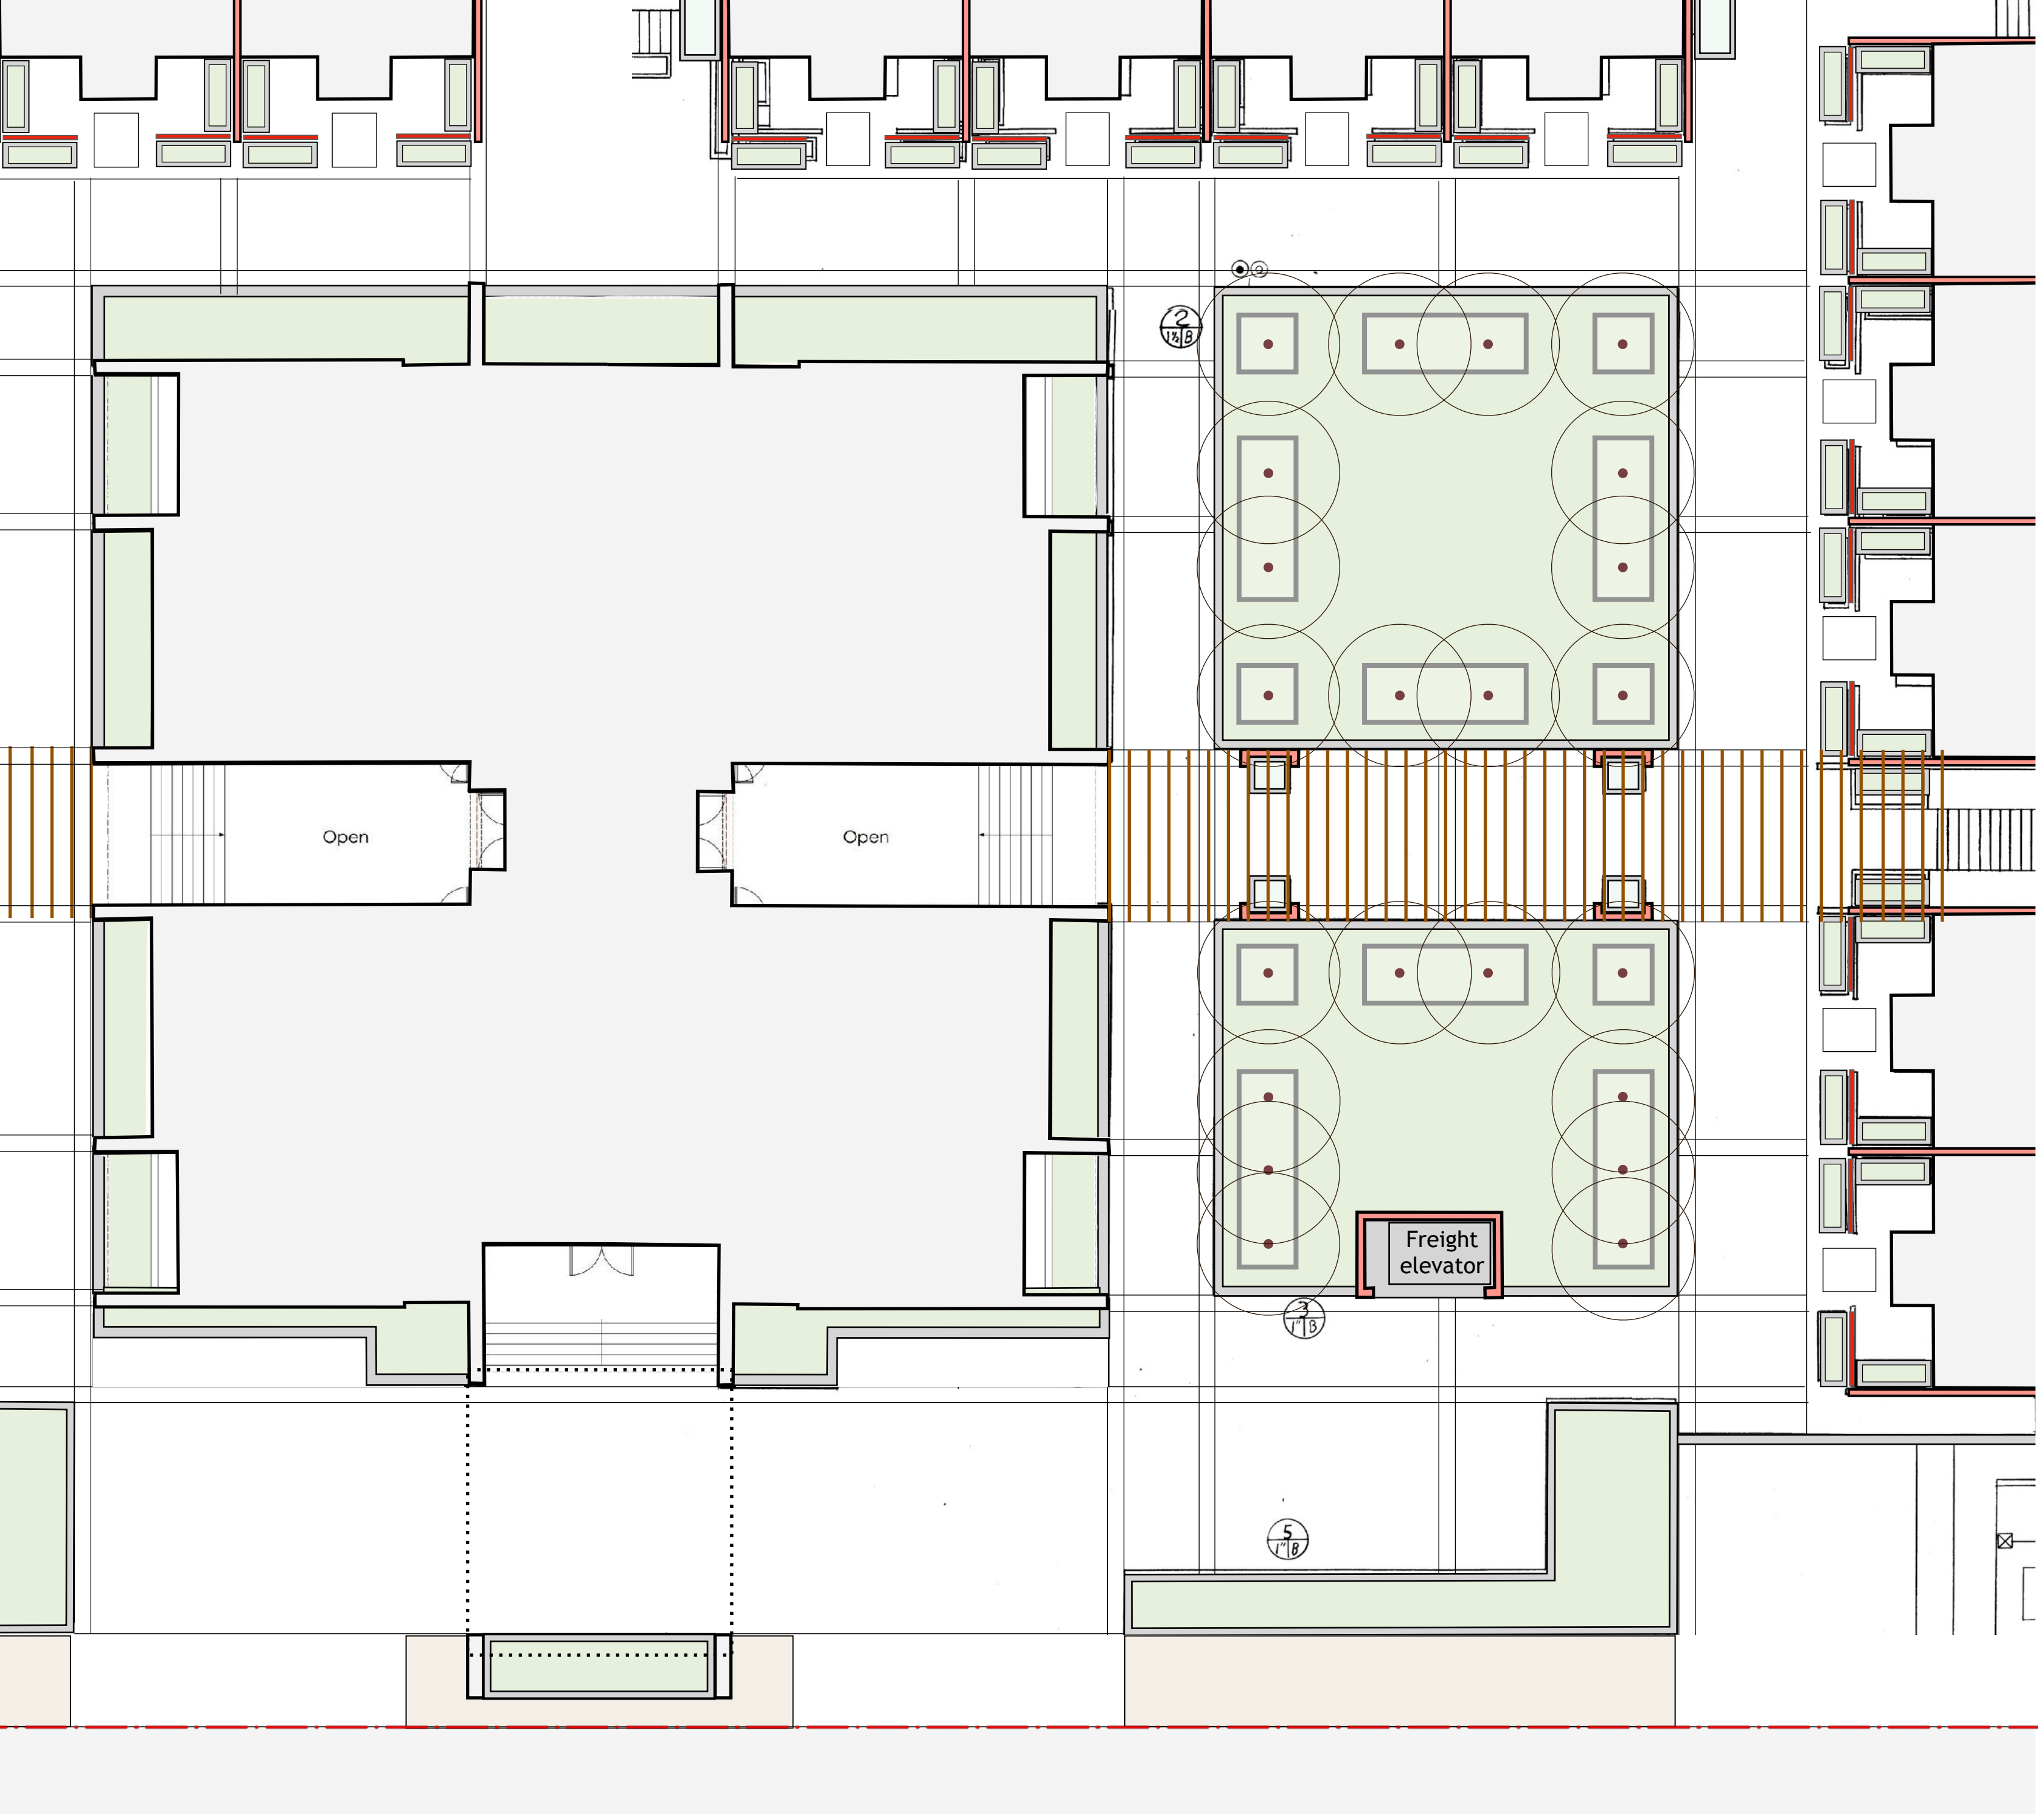
1

The two primary planting areas consisted of a low section, about 15” to 18” deep, intended only for ground cover. The northern half is about 48 feet square; and the southern half is about 48 feet wide by 40 feet high. Set within those larger planters was a grouping of 13 large concrete planters—six feet square, and longer—providing each tree with about four cubic yards of soil.

There were no steps onto the ground cover, or breaks in the perimeter walls, so presumably, the intent was only to provide a green roof over the garage. The only encroachment was the area for the freight elevator on the southern edge. Each townhome had four planters separated by tall, wooden garden walls.

The cross-section below is to the same scale as the plan and shows the lower section for ground cover, the six foot wide planters, and trees reaching about 20 feet in height.

As leaks started developing during the 80s, Portland Center attempted to divert water to the inside wall by installing galvanized metal channels, which are still visible. From there, water has had no place to go.

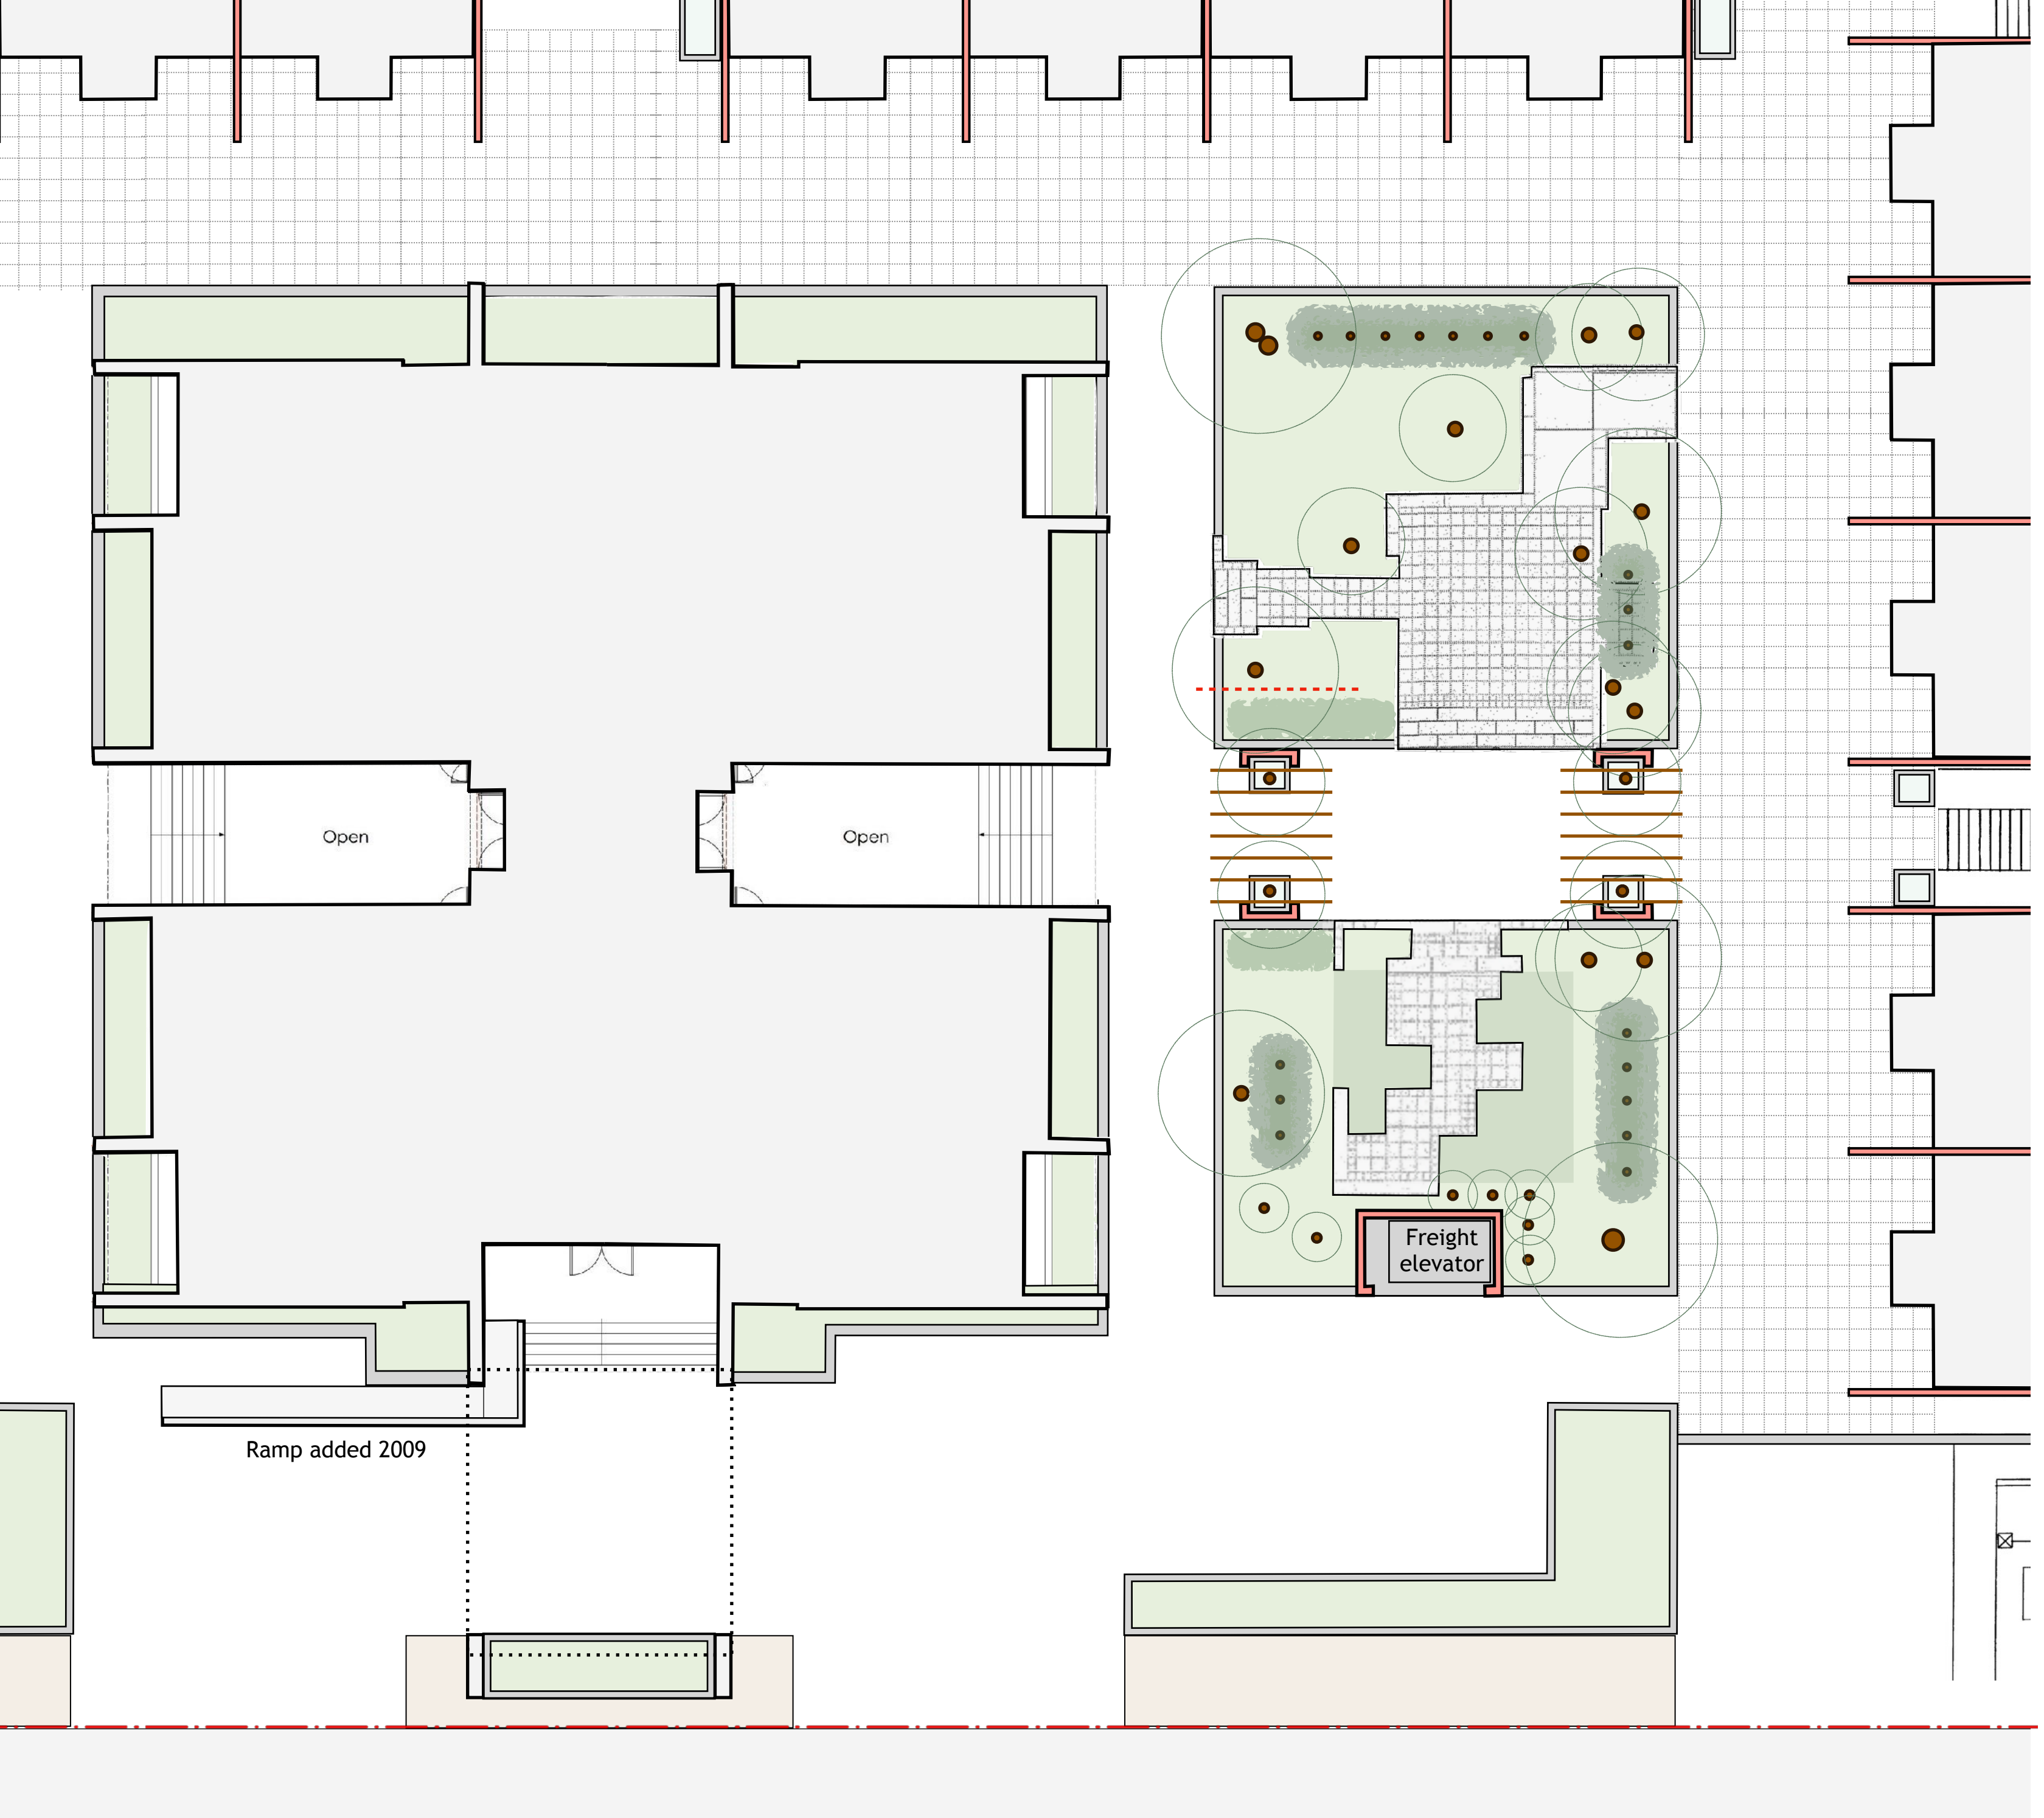
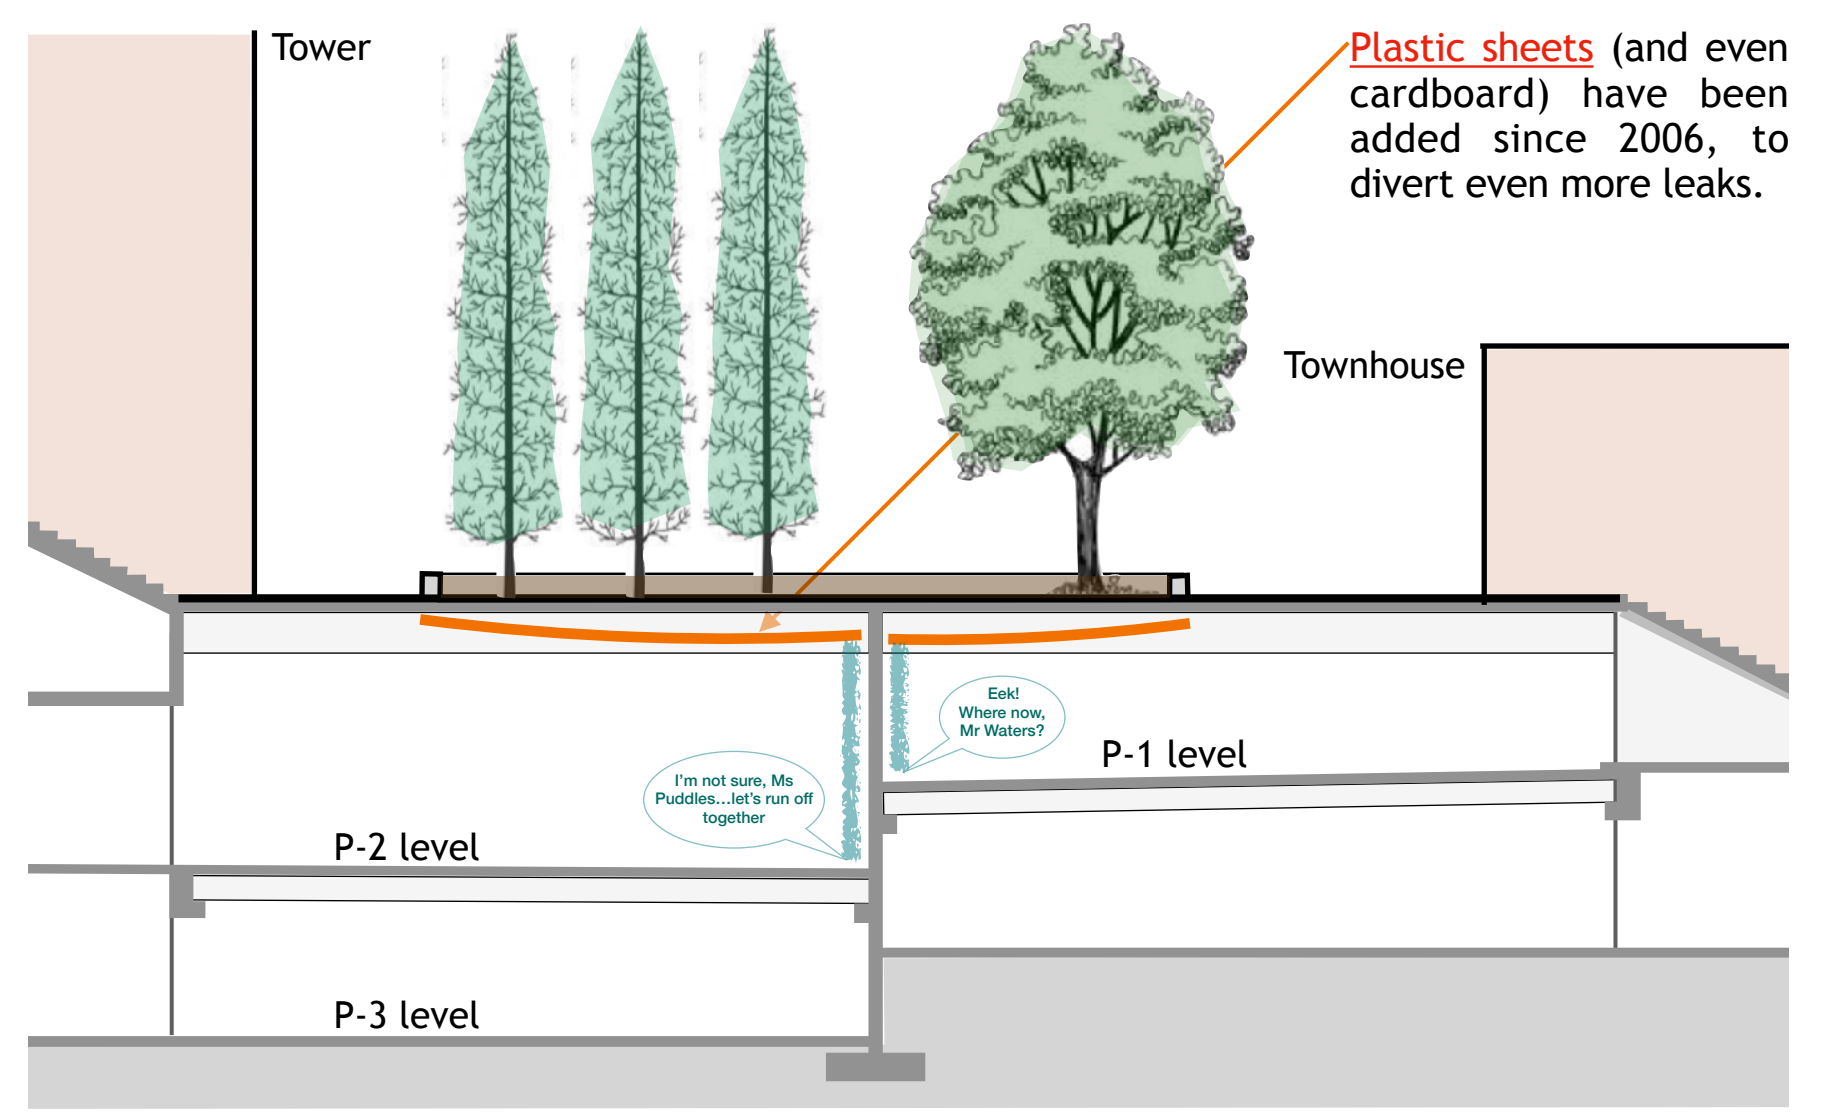
2

The two primary planting areas remain, but have been modified by four breaks in the perimeter walls to allow access onto newly created paved areas. The deep tree wells have been removed so that all plant materials now compete within the same 15" to 18" of soil intended previously only for ground cover.

The cross-section is to the same scale as the previous section and shows the remaining low section, originally intended for ground cover, and yet some trees reaching about 40 feet in height—where do the roots go? Certainly not down.

New concrete pavers (indicated with the small grid) were added in 2016, as part of the courtyard project, but other walkway areas retain the waterproofing membrane dating back decades, cited on the previous page, although not as old as the planter basins and not nearly as deteriorated.

The important point is that the two planted areas may have been changed in character, but the waterproofing membrane of the 60s was not upgraded. Based on the technology available back then, the first sign of leaking would have occurred around 1980—four decades ago—and today still remains unchecked.

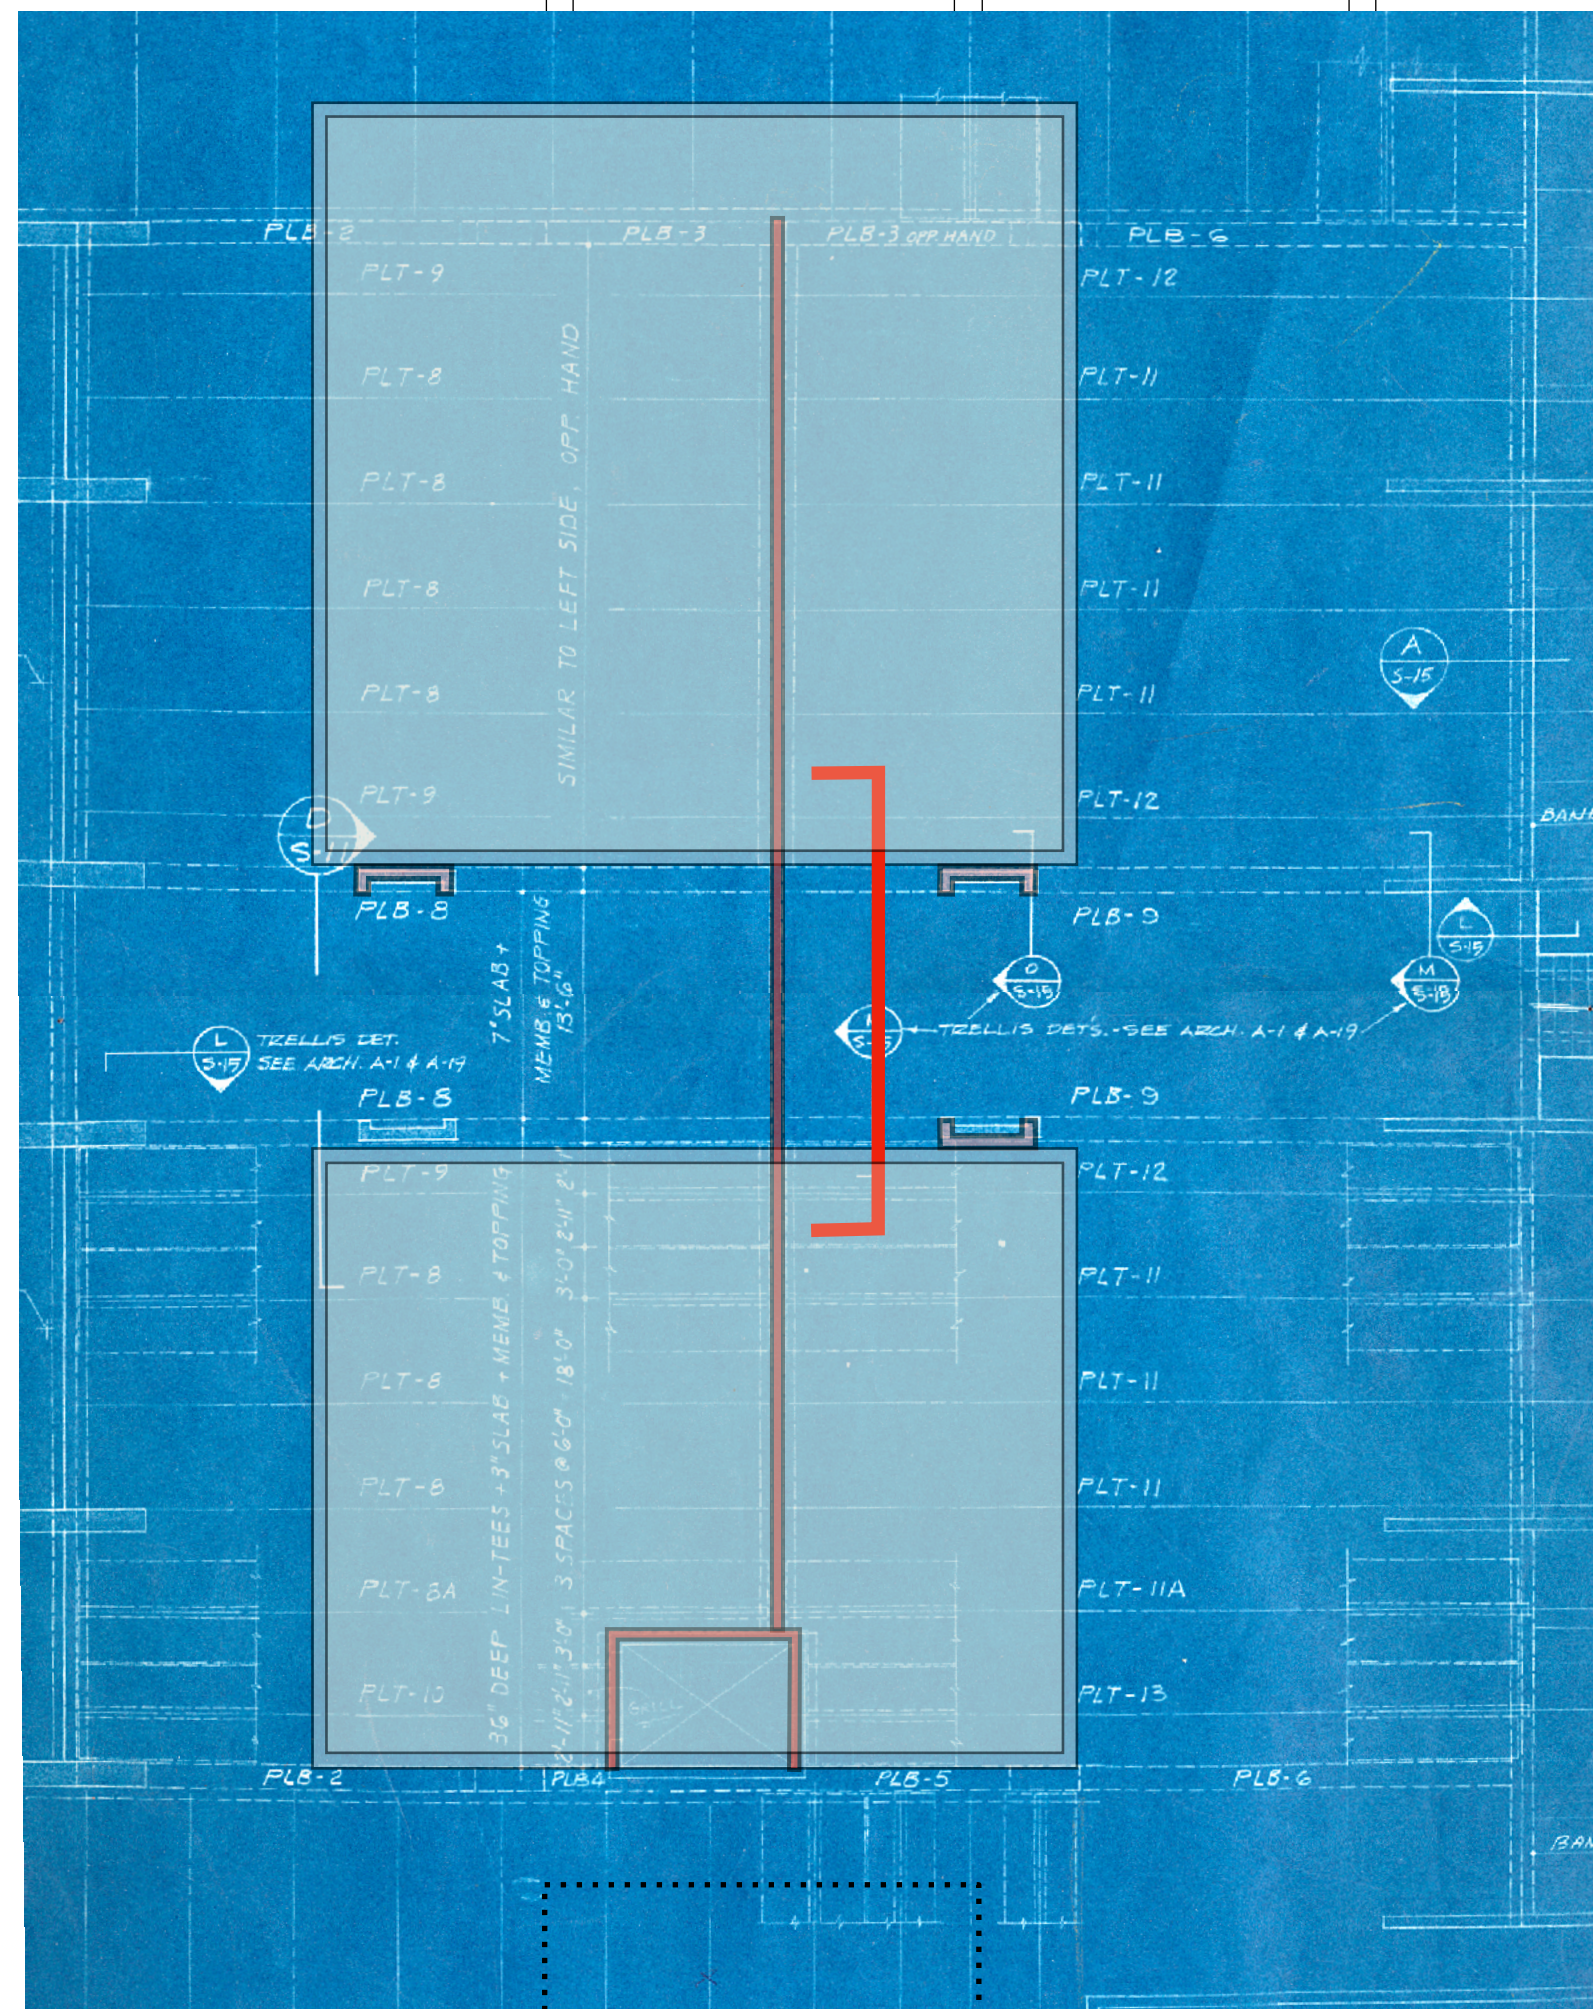
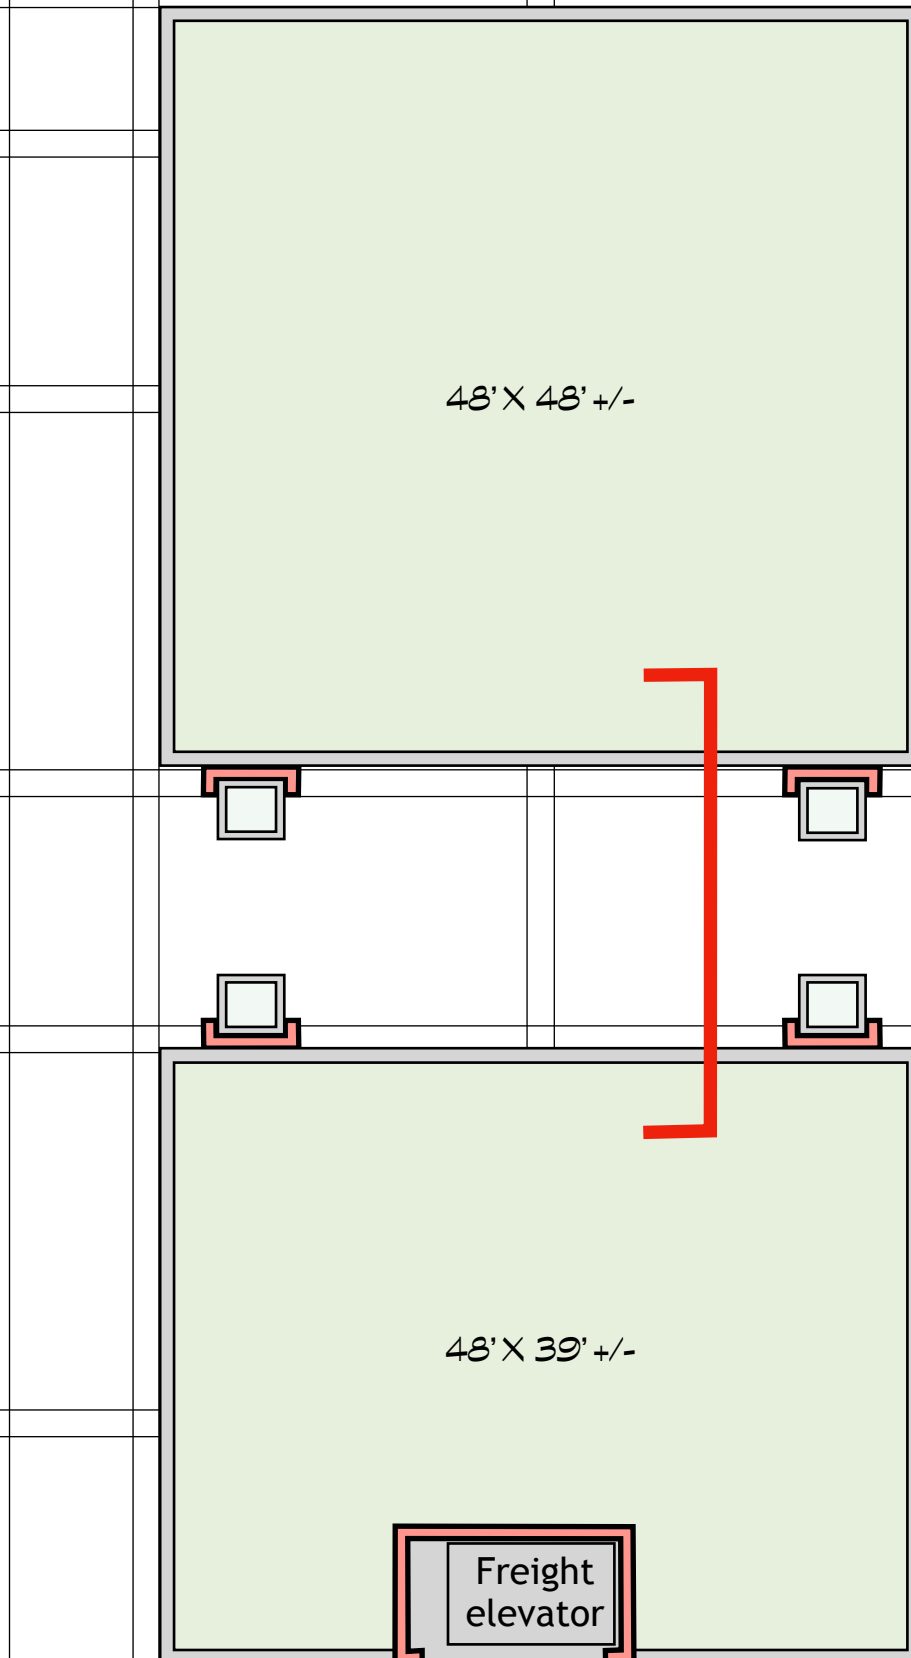
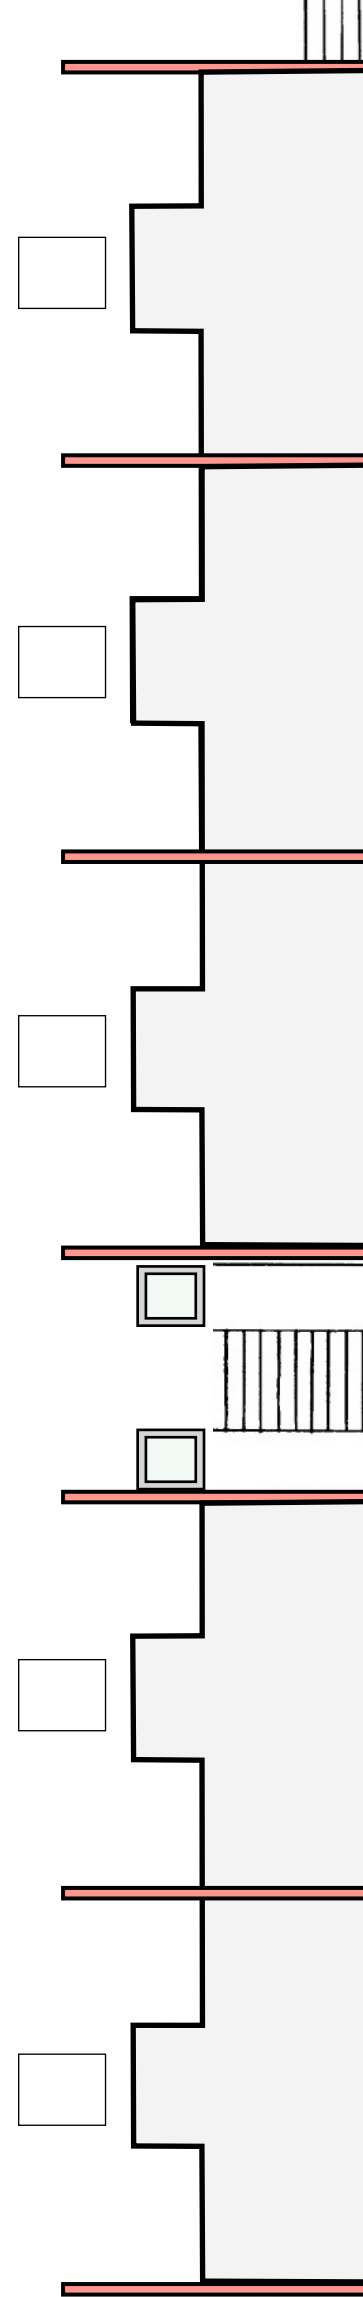
3 the planters

It is important to realize that the load associated with the planter curbs and the soil was calculated into the structural design and should not be altered significantly—a lesson learned from the previous courtyard project. In other words, don't remove the planters altogether and don't

These excerpts from the original blueprints are invaluable. The image to the far left, and the section below, show the framing just below the planters, which are merely 15" deep concrete curbs set on top of the deck. (They weren't even indicated on the structural drawings.) The center bay, which corresponds to the walkway, is poured-in-place concrete along with two enormous beams, but all the other framing consists of precast concrete T-beams, deliberately spaced about an inch apart to hide electrical conduit for lighting, which has long ago shorted out and had to be abandoned. That's where the leaks find their paths.

In the section below, the original waterproofing associated with the planters is indicated in red; the much later waterproofing over the walkways, is indicated in yellow. The point is they are not interrelated and could be dealt with independent of each other, as the first phase of the courtyard project had done.

From the visible evidence, it appears that the planter waterproofing has never been replaced, and yet between aggressive tree roots and rats, it is likely that what remains of the original waterproofing will come out as fragments. The membrane over the walkways is newer and not susceptible to roots or rats.

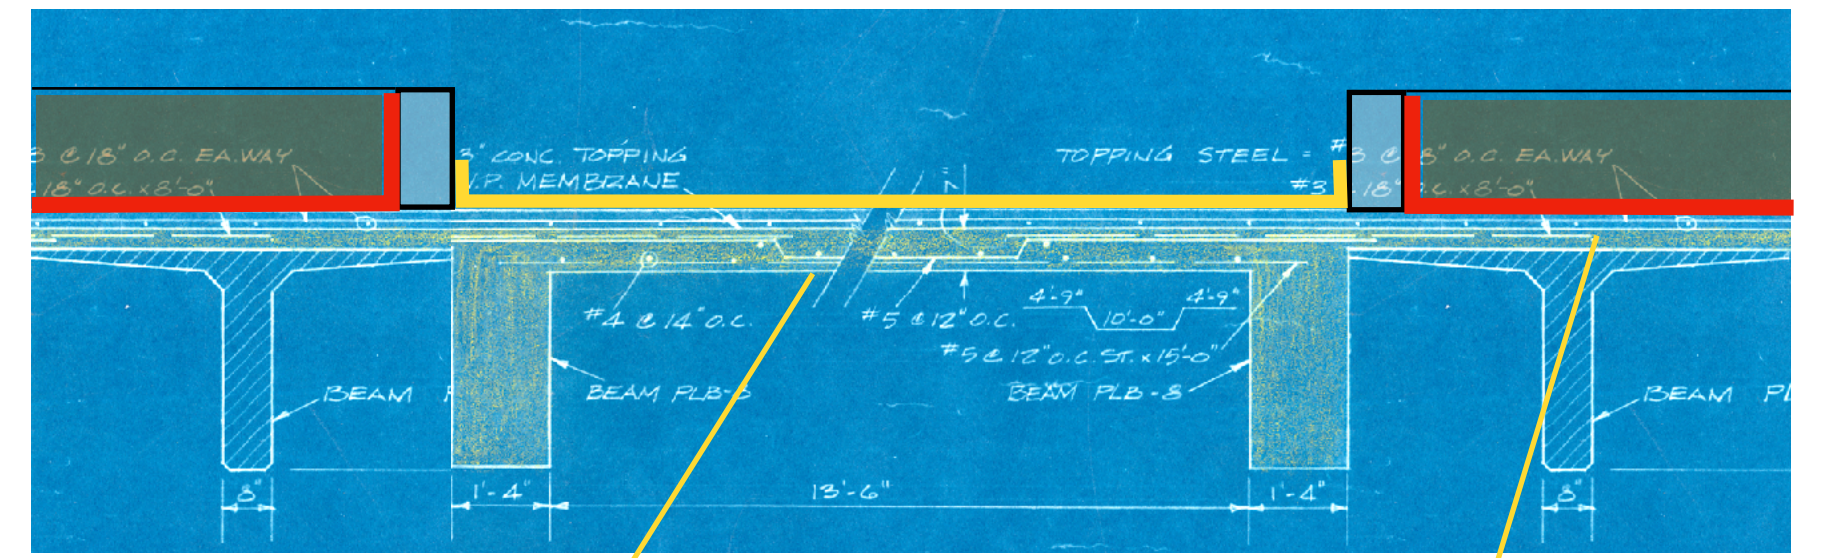
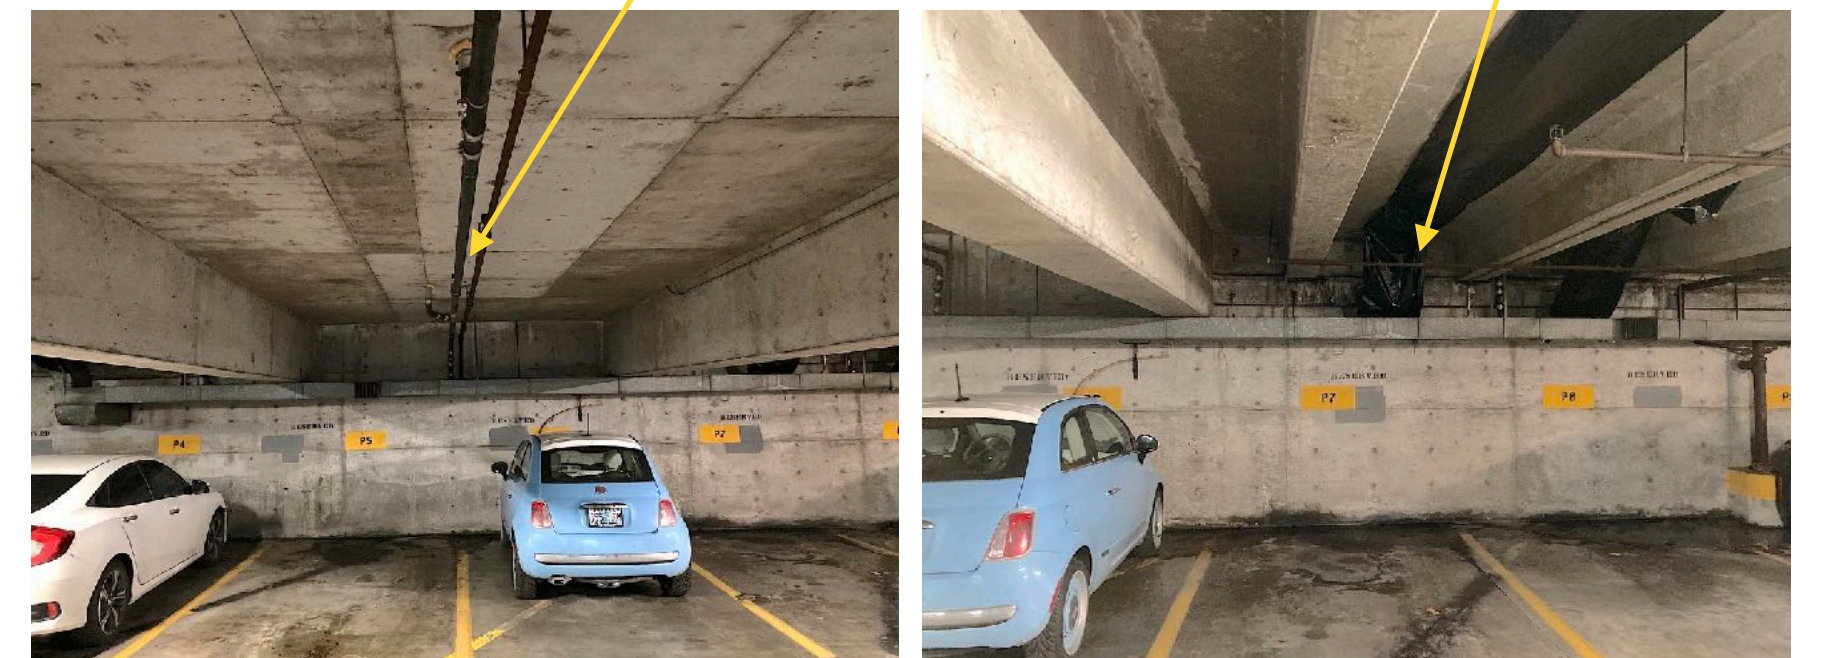
As the two photos indicate, one can walk around the garage and see where the planters are, above, just by tracing the wet areas and the plastic sheets. The center section—without planter—is clean and dry. Immediately to the right the concrete is wet and plastic sheets attempt to divert the seepage.

One can walk around the garage and see where the planters are, above, just by tracing the wet areas and the plastic sheets. The photo to the left taken below the center section—without planter—is clean and dry. Immediately to the right the concrete is wet and plastic sheets attempt to divert the seepage.

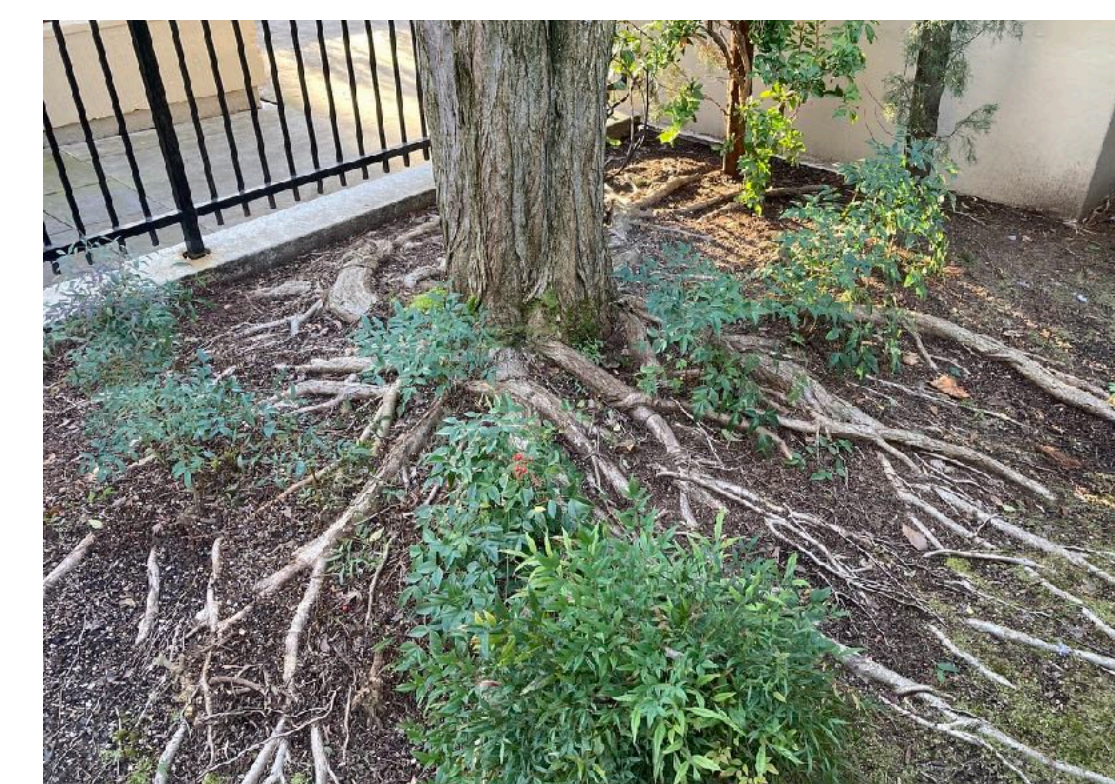
The root structure of Katsura 1—roots are doubling back on themselves and burrowing under the concrete curb wall. Sad.

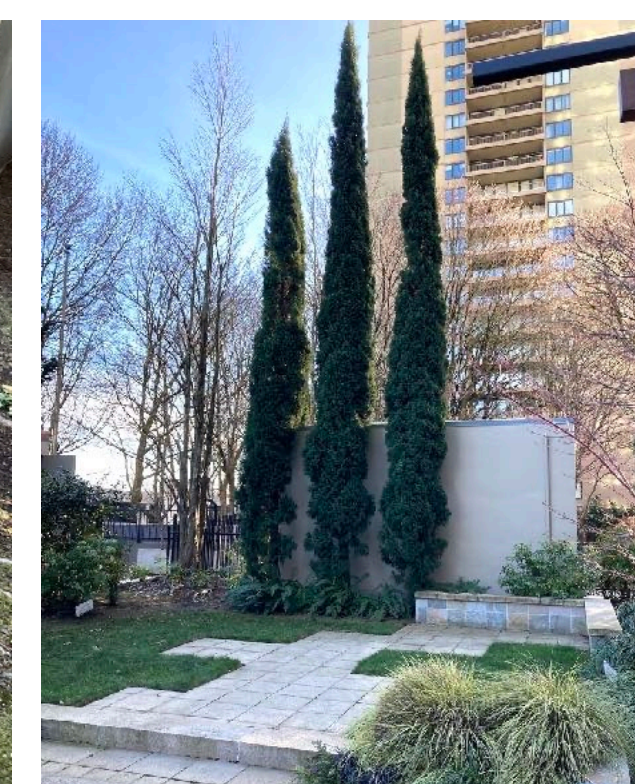
The Italian cypresses are happier, but have grown so tall that they are vulnerable to high winds.
