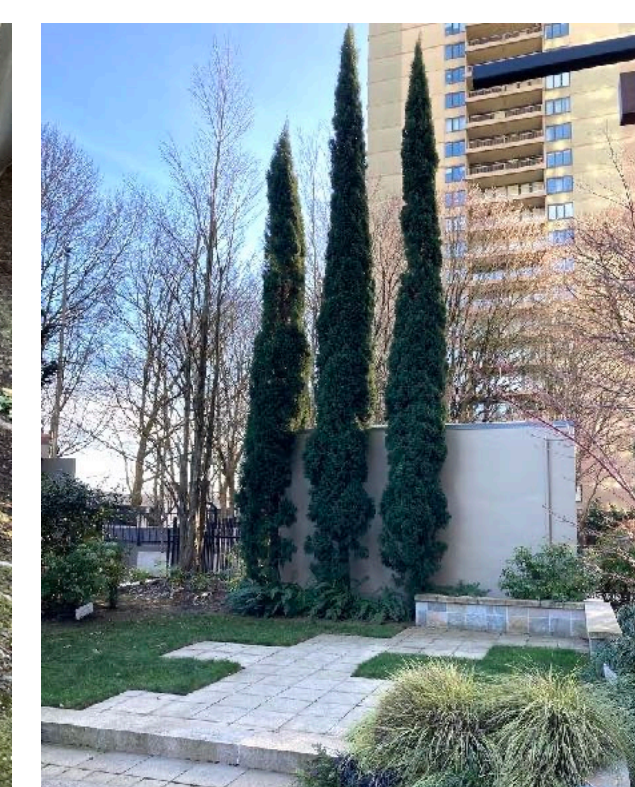
The adjacent Italian cypresses, although better adapted to the limited soil, have become so tall, that they are vulnerable to high winds. Star magnolia 1, has a long root system that has become entangled with the ailing Katsura. Kousa dogwood 1 has its roots trapped by the concrete walkway. On and on. Conversely, Camellias and other shrubs have fared well in the restrictive environment. And as for the remnant, token lawn...? Yawn.

The Italian cypresses are happier, but have grown so tall that they are vulnerable to high winds.

The conclusion is that smaller trees (between 2 and 5), and all of the shrubs, could be root-balled and salvaged during the upcoming courtyard project, phase 2. But, all the mature trees (between 14 and 17) have outgrown their environment. Even if the trees were salvageable, the question is: would one replant a mature tree back to a hostile environment? Or, is this an opportunity to reevaluate what kind of plants materials would be more appropriate for a shallow planting bed and win the approval of the ASPCP?
