# the leaks

## Harrison West Condominium

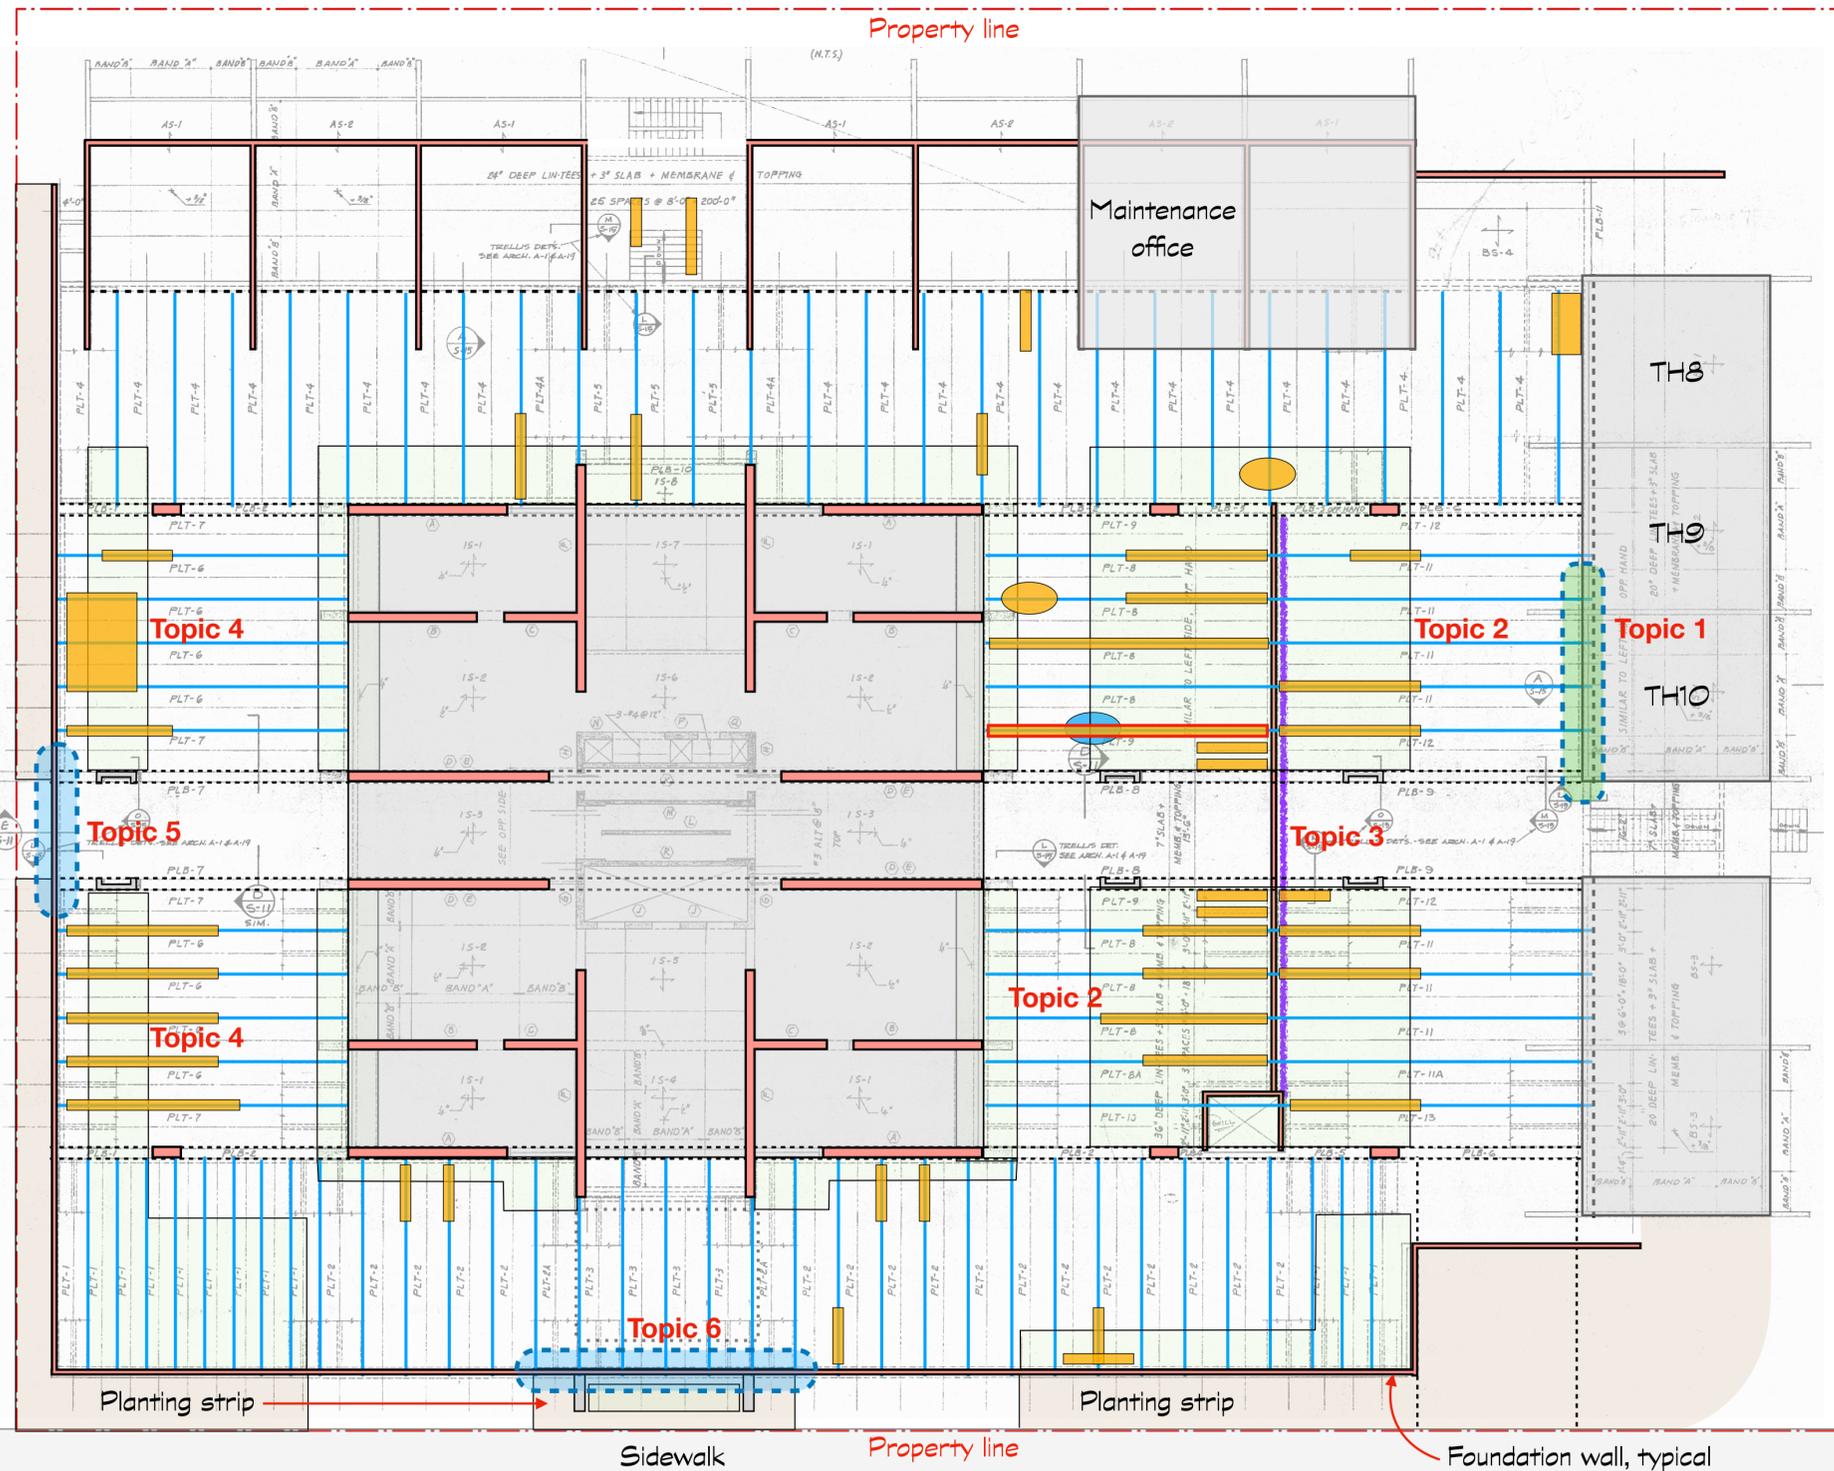
By looking up at the underside of the courtyard level, from the upper parking level [a “reflected ceiling plan”], one can see 40+ leak locations indicated in yellow, the predominance of which are diverted by galvanized channels, indicating that those leaks were already existing long before the 2005 conversion. Locations with plastic sheets indicate attempts by HW Maintenance to deflect leaking away from vehicles. Note that all the leaks find their way through the slab through gaps between the T-Joists—the gaps are indicated by blue lines.

The areas identified by oblong shapes—Topics 1, 5 and 6—indicate areas affecting wall surfaces more so than leaks from above, primarily along foundation walls.

**Topic 1** There is a rusted area at the top of the wall, below TH10 and part of TH9, that suggests a past history of water penetration along the edge of the townhome foundation walls. It’s possible, and likely, that the project of 2015/16 corrected this problem and what remains is purely aesthetic, although there is another problem area at the north corner below TH8, that warrants further investigation.

**Topic 2** Overhead leaks are located in relation to the courtyard-level planters, indicated in pale green. All leaks are directed towards the structural wall in the middle. The two yellow ovals are locations where dripping leaks are visible, but no attempt has been made to divert them. The blue oval is a perennial wet spot that corresponds to the worst of all the leaking areas, highlighted with a red outline.

**Topic 3** The squiggly purple line indicates a perennially wet rivulet of water along the 8” concrete structural wall, since the two slabs slope and divert all runoff to this wall, without any drainage. Evidence of water seeping into the concrete wall is noticeable on the west side of the wall and even at the lower parking level, below the purple line. This situation should be of greater concern than other areas, which might be more aesthetic in nature, but not likely to fail.

**Topic 4** Similar to Topic 2, there is a series of overhead leaks, most of which are diverted by galvanized channels and even cardboard. There is one area, indicated with the yellow rectangle, that seems to be a plastic tent covering several parking spaces. The correspondence with planters, above, is not as obvious as in Topic 2.

**Topic 5** Corresponding to the steps of the west side-entrance, the ceiling and wall of the upper garage level indicate discoloration and efflorescence that suggest that the waterproofing membrane underneath has been compromised. This area is the most difficult to assess by visual observation alone.

**Topic 6** Corresponding to the width of the porte-cochère and the planted area between the sidewalk, the ceiling and wall of the upper garage level, and the wall of the lower garage level, indicate discoloration and efflorescence that suggest that the waterproofing membrane along the foundation wall has been compromised. Large cracks along the edge of the foundation, and down the middle of the porte-cochère, are obvious points of water intrusion into the slab below and into the ground adjacent to the foundation.

**Recommendation** Verify the integrity of two typical, but extreme conditions—one for a planter, the other for a foundation wall—by authorizing two test pits to expose and extract samples of waterproofing membrane. We proceed from there.
